Annual Inspection

Creech St Michael MUGA 2

Inspection Ref: 1990887

Inspected: 2-March-2023 - 08:53 by Lyn Williams RPII Annual Inspector

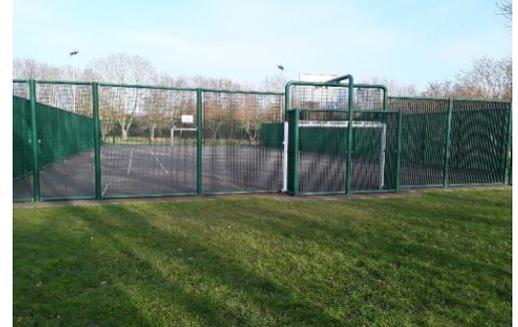
Item: Multi Use Games Area (MUGA)
Manufacturer: Lightmain Engineering
Surface Type: Bitmac
Item Quantity: 1
Equipment Compliance: Yes
Surface Area Compliance: N/A

One gate was locked or secured at the time of the inspection and a full inspection could not be undertaken - Complete the inspection of the gate when re-opened

Stickers have been put on the cross bar - Remove the stickers

There is some graffiti present - Remove the graffiti

The basketball hoop is damaged - Repair the damaged hoop

BS EN 15312 states that gaps whose dimensions change during use shall have a minimum dimension of 18mm - Ensure crushing hazards are removed

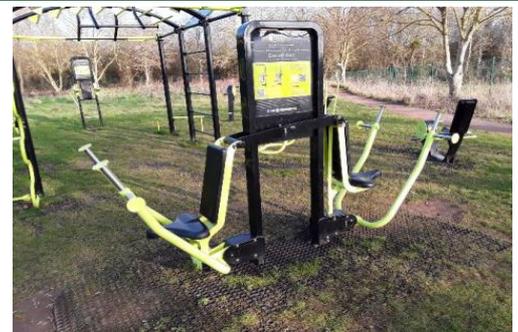
Item: Double Fitness Station
Manufacturer: The Great Outdoor Gym Company
Surface Type: Grass Matrix Tiles
Item Quantity: 1
Equipment Compliance: No
Surface Area Compliance: N/A

The paintwork on this item has been damaged or worn exposing the metal underneath which is rusting - Treat any rusting components and repaint

BS EN 16630 - 4.3.1 states that fitness equipment shall be designed so when at rest, the equipment shall automatically adjust so that the equipment is ready for the next user - Service the item

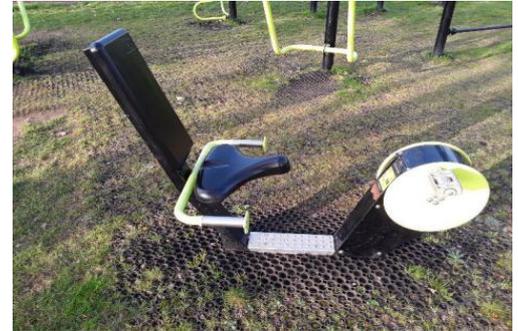
Item: Cycle
Manufacturer: The Great Outdoor Gym Company
Surface Type: Grass Matrix Tiles
Item Quantity: 1
Equipment Compliance: Yes
Surface Area Compliance: N/A

The paintwork on this item has been damaged or worn exposing the metal underneath which is rusting - Treat any rusting components and repaint

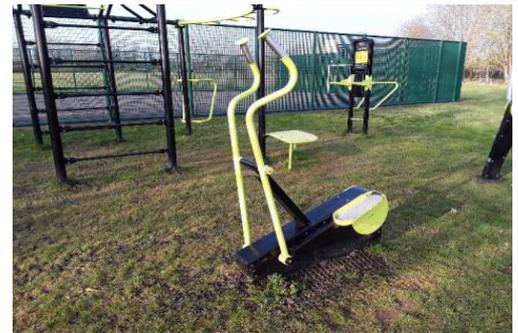
Item: Cross Trainer
Manufacturer: The Great Outdoor Gym Company
Surface Type: Grass Matrix Tiles
Item Quantity: 1
Equipment Compliance: Yes
Surface Area Compliance: N/A

The bearing is showing signs of wear - Monitor for any further deterioration and replace as required

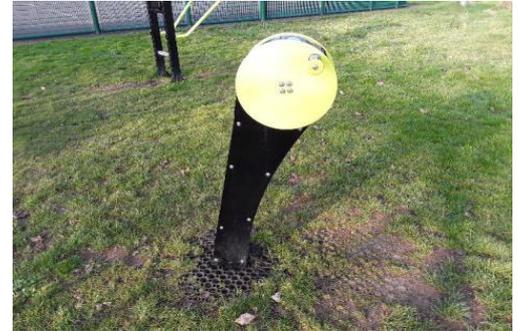
Item: Hand Bike
Manufacturer: The Great Outdoor Gym Company
Surface Type: Grass Matrix Tiles
Item Quantity: 1
Equipment Compliance: Yes
Surface Area Compliance: N/A

The paintwork on this item has been damaged or worn exposing the metal underneath which is rusting - Treat any rusting components and repaint

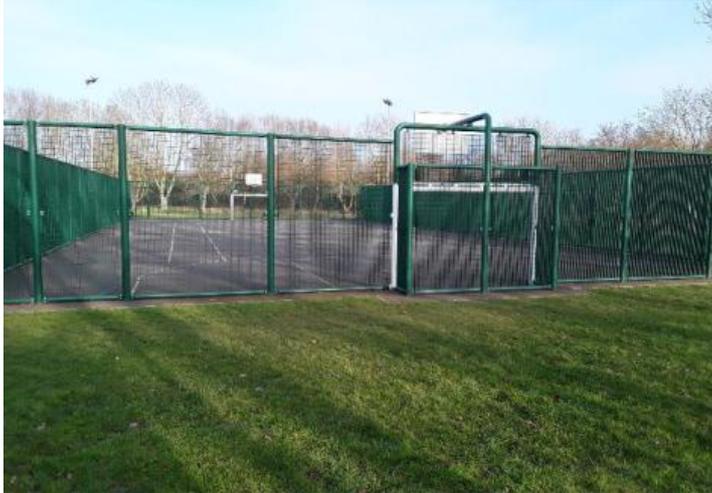
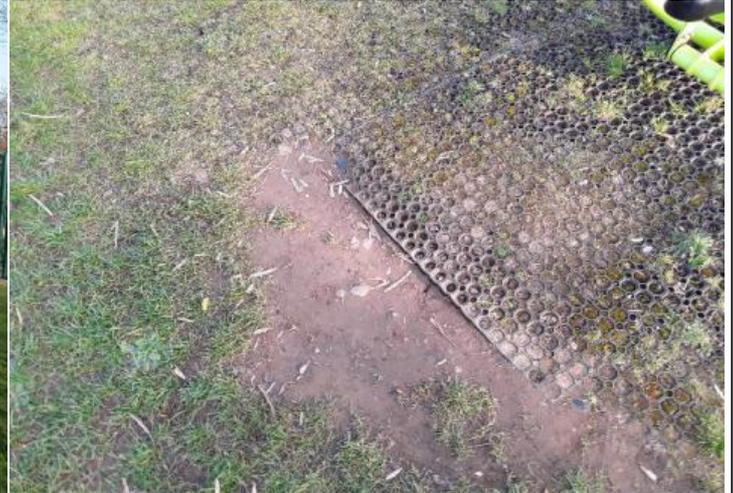
Item: Ancillary Items - Site General
Manufacturer: Not Applicable

Finding: The edges of the grass mat surface in the outdoor fitness area have not been installed in accordance with the API Code of Practice

Action: Tuck in edges of grass mat to remove trip hazards

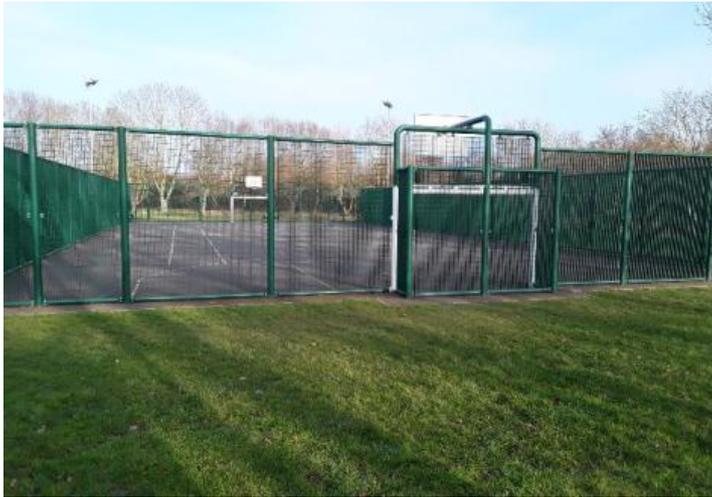
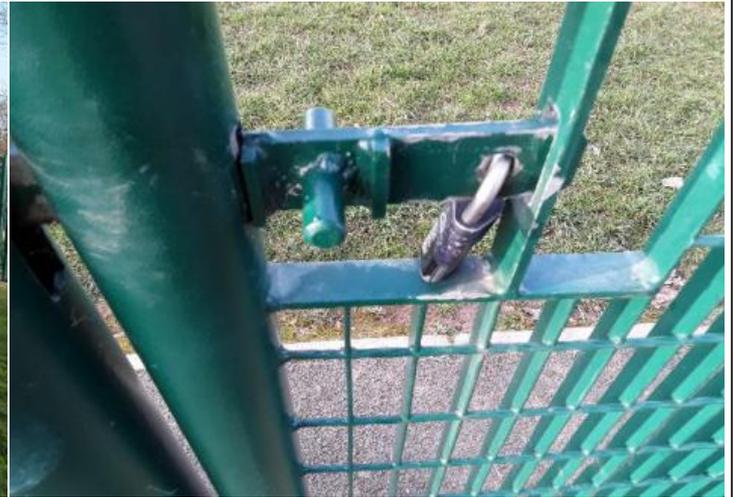
Item: Multi Use Games Area - Multi Use Games Area (MUGA)
Manufacturer: Lightmain Engineering
Risk Level: N - Risk Assessment not Undertaken
Surface: Bitmac

Finding: One gate was locked or secured at the time of the inspection and a full inspection could not be undertaken
Action: Complete the inspection of the gate when re-opened

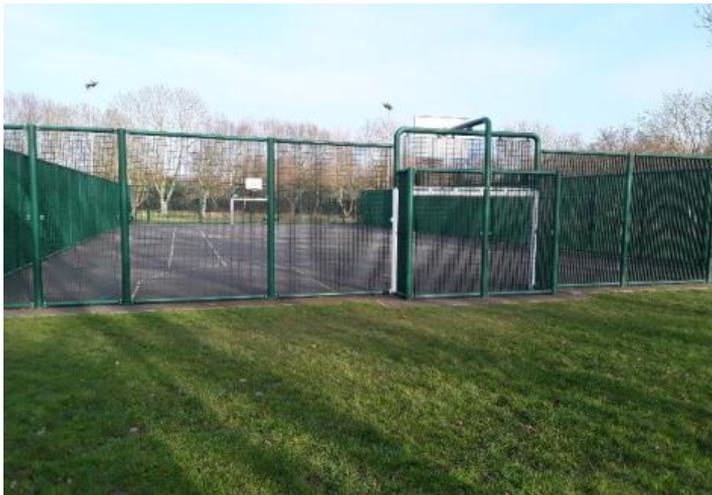
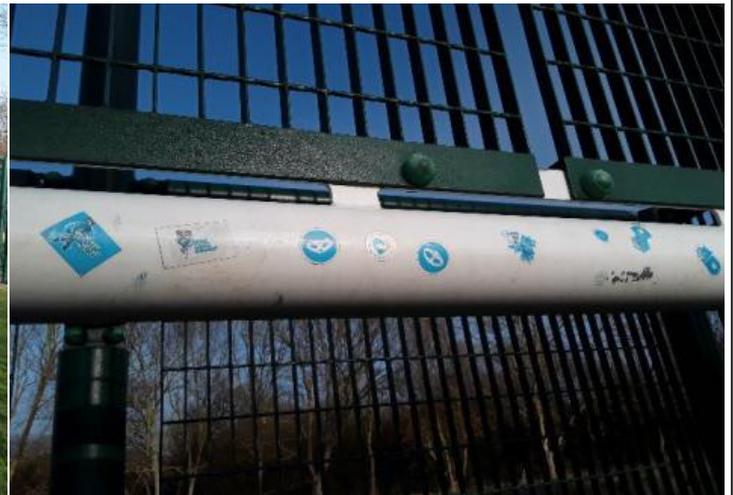
Item: Multi Use Games Area - Multi Use Games Area (MUGA)
Manufacturer: Lightmain Engineering
Risk Level: V - Very Low Risk
Surface: Bitmac

Finding: Stickers have been put on the cross bar
Action: Remove the stickers

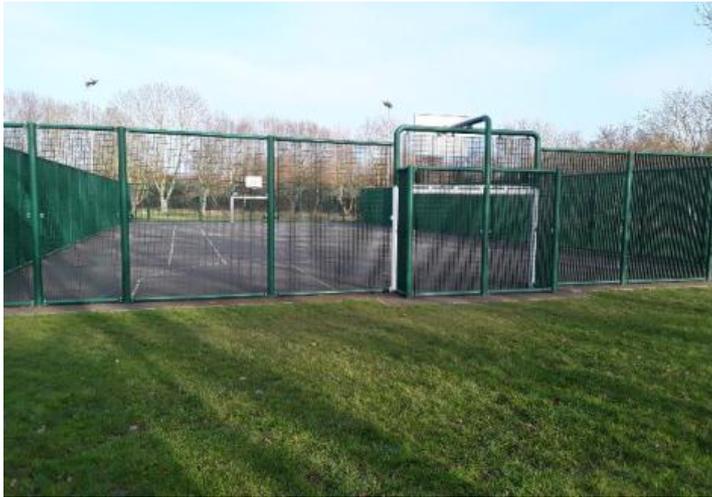
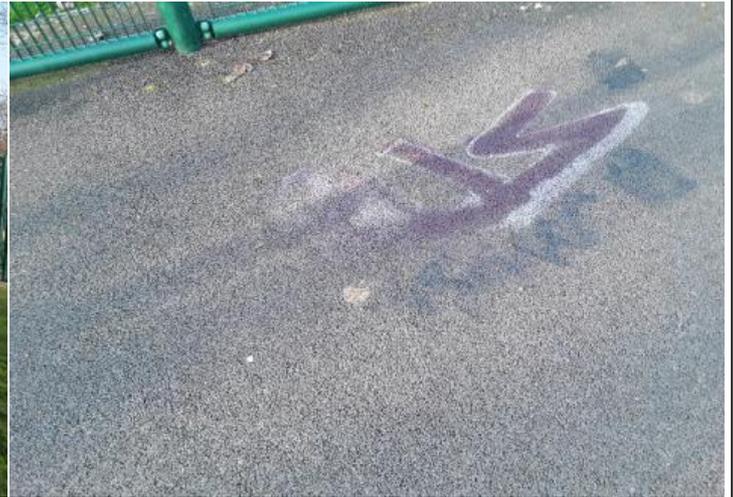
Item: Multi Use Games Area - Multi Use Games Area (MUGA) **Risk Level:** V - Very Low Risk
Manufacturer: Lightmain Engineering **Surface:** Bitmac

Finding: There is some graffiti present

Action: Remove the graffiti

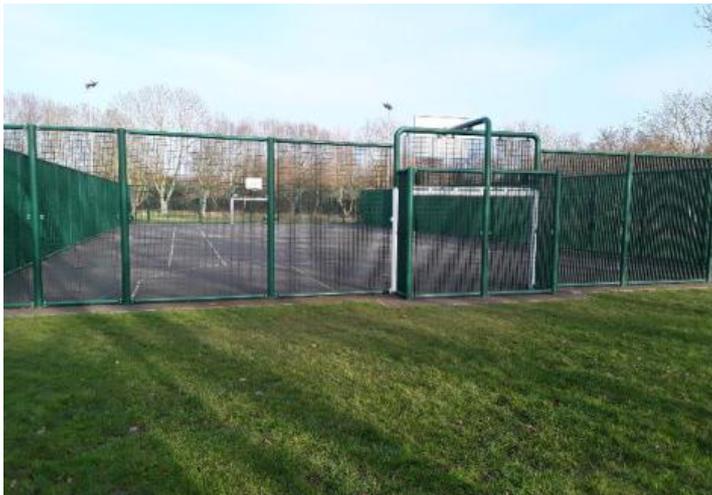
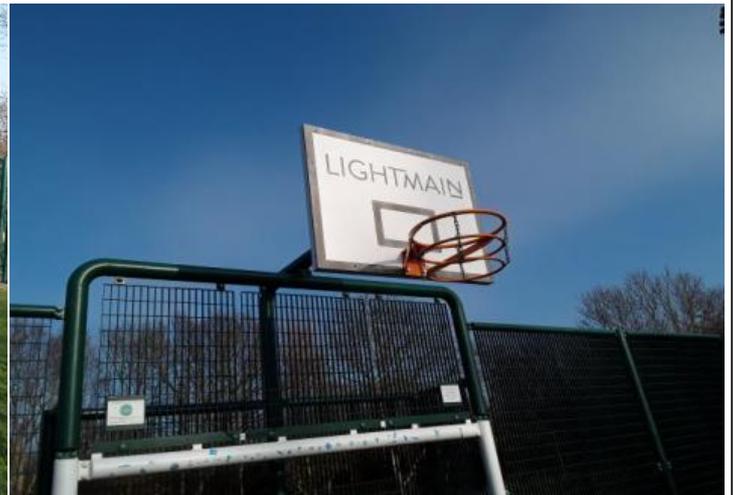
Item: Multi Use Games Area - Multi Use Games Area (MUGA) **Risk Level:** L - Low Risk
Manufacturer: Lightmain Engineering **Surface:** Bitmac

Finding: The basketball hoop is damaged

Action: Repair the damaged hoop

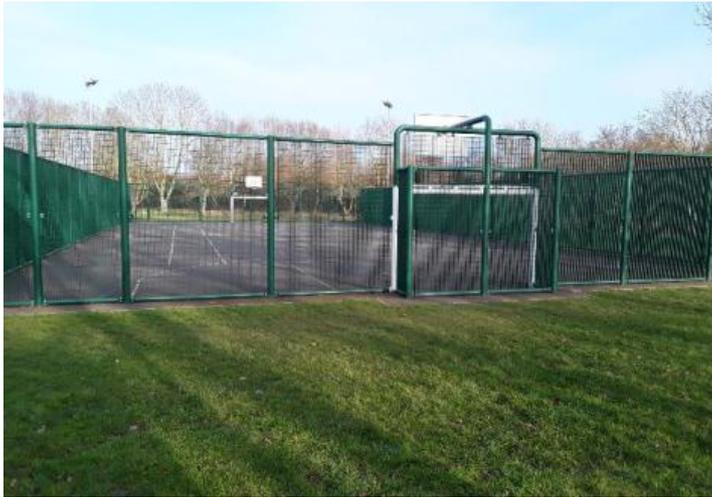
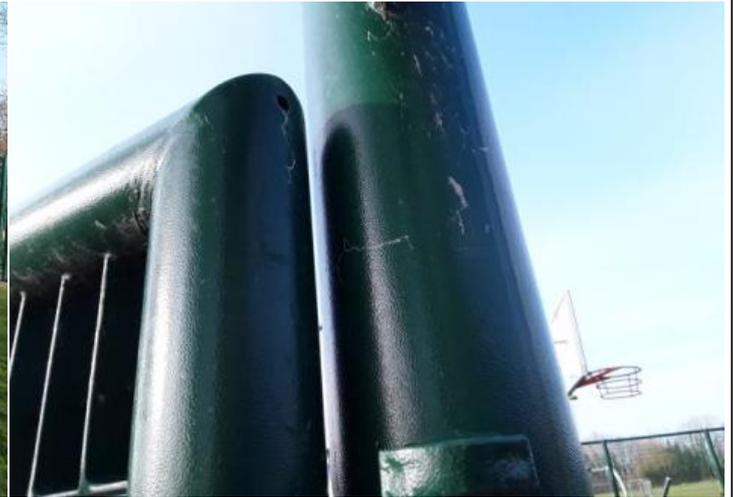
Item: Multi Use Games Area - Multi Use Games Area (MUGA)
Manufacturer: Lightmain Engineering
Risk Level: L - Low Risk
Surface: Bitmac

Finding: BS EN 15312 states that gaps whose dimensions change during use shall have a minimum dimension of 18mm
Action: Ensure crushing hazards are removed

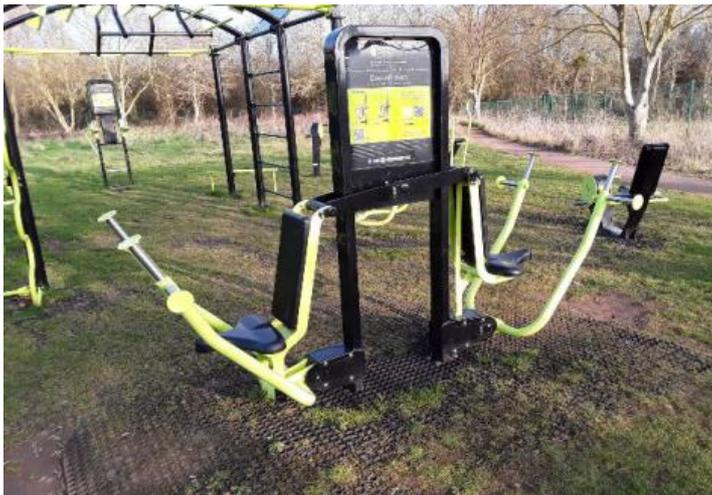
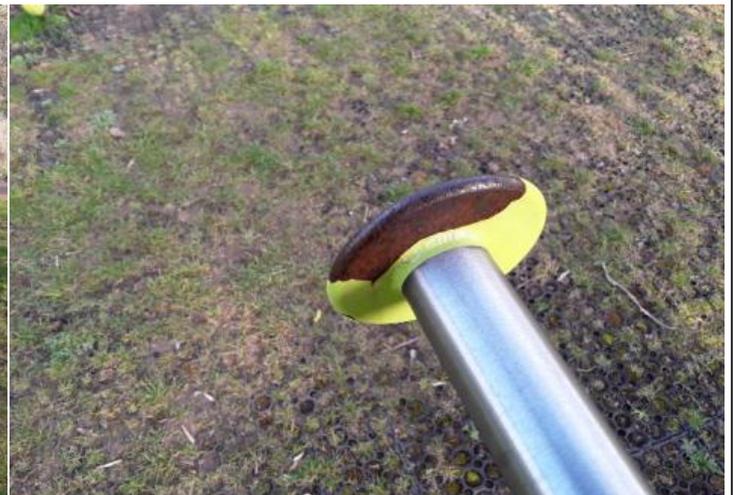
Item: Outdoor Fitness Equipment - Double Fitness Station
Manufacturer: The Great Outdoor Gym Company
Risk Level: L - Low Risk
Surface: Grass Matrix Tiles

Finding: The paintwork on this item has been damaged or worn exposing the metal underneath which is rusting
Action: Treat any rusting components and repaint

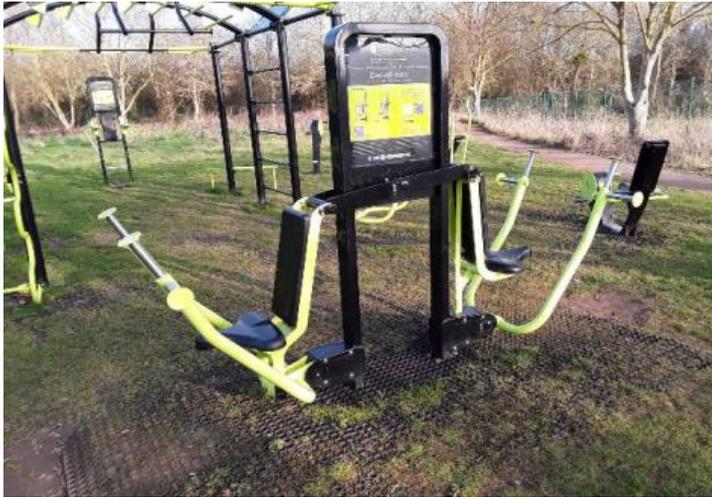
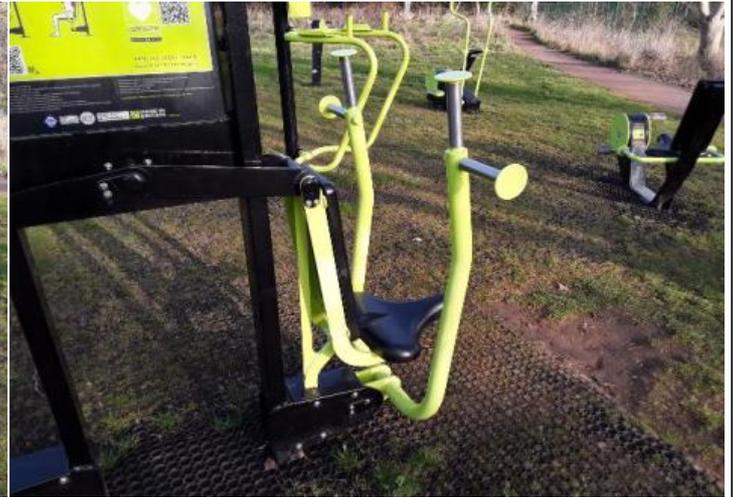
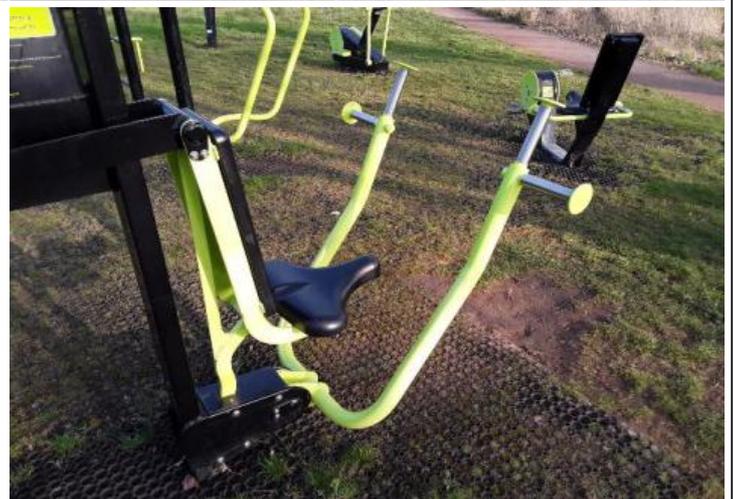
Item: Outdoor Fitness Equipment - Double Fitness Station
Manufacturer: The Great Outdoor Gym Company

Finding: BS EN 16630 - 4.3.1 states that fitness equipment shall be designed so when at rest, the equipment shall automatically adjust so that the equipment is ready for the next user
Action: Service the item

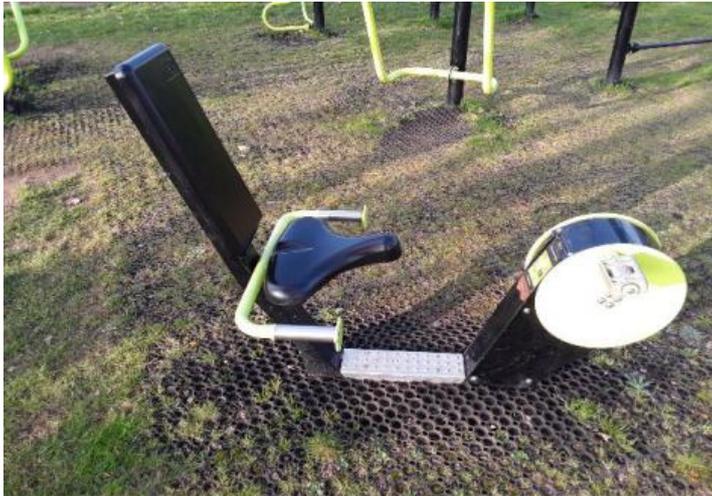
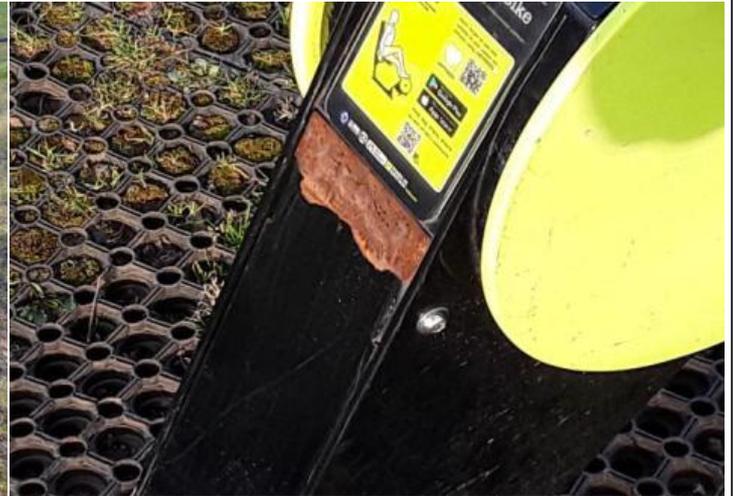
Item: Outdoor Fitness Equipment - Cycle
Manufacturer: The Great Outdoor Gym Company

Finding: The paintwork on this item has been damaged or worn exposing the metal underneath which is rusting

Action: Treat any rusting components and repaint

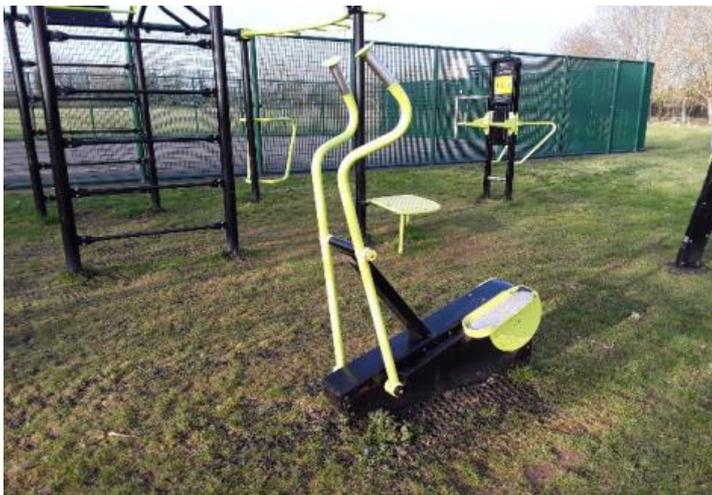
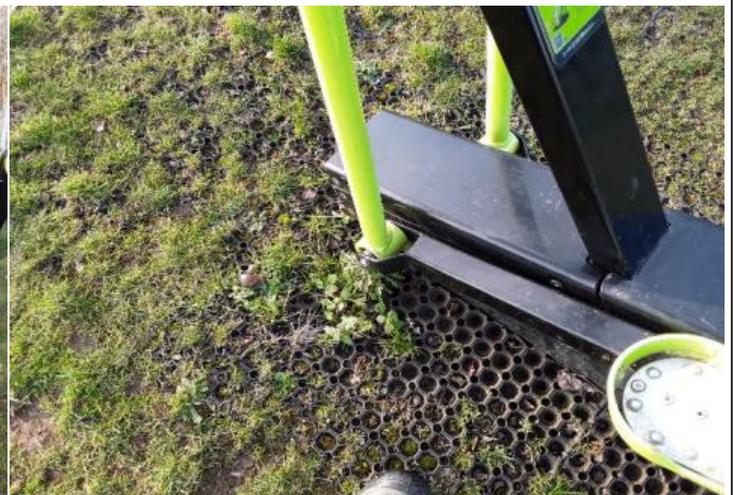
Item: Outdoor Fitness Equipment - Cross Trainer
Manufacturer: The Great Outdoor Gym Company

Finding: The bearing is showing signs of wear

Action: Monitor for any further deterioration and replace as required

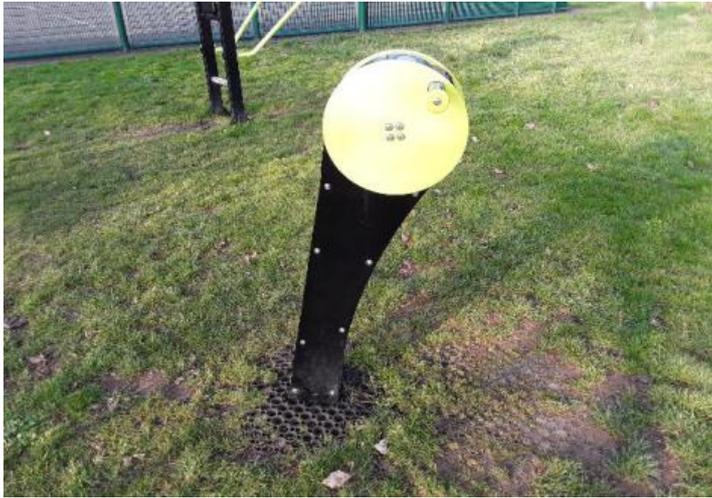
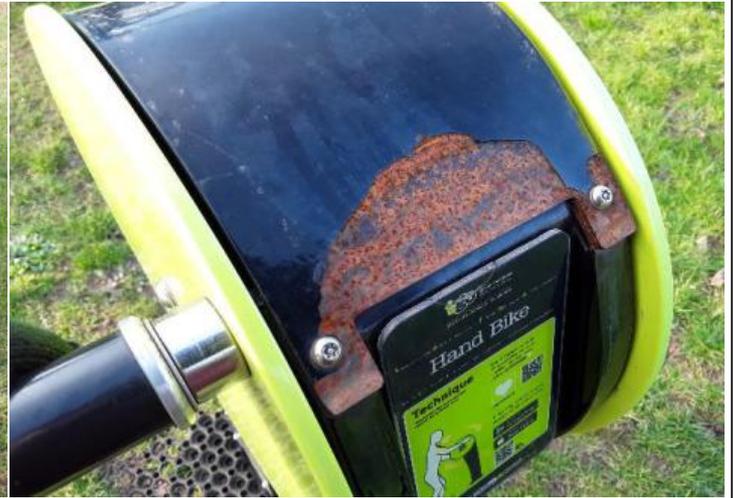
Item: Outdoor Fitness Equipment - Hand Bike
Manufacturer: The Great Outdoor Gym Company

Finding: The paintwork on this item has been damaged or worn exposing the metal underneath which is rusting

Action: Treat any rusting components and repaint
