Annual Inspection

Creech St Michael MUGA 2

Inspection Ref: 1990887

Inspected: 2-March-2023 - 08:53 by Lyn Williams RPII Annual Inspector

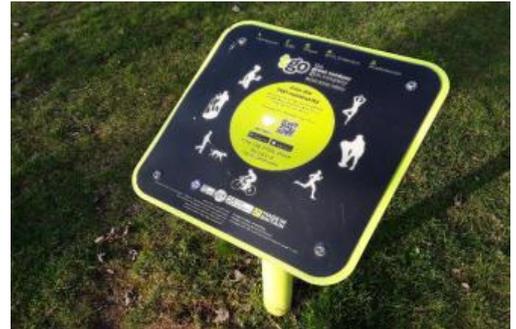
Finding 1

Item: Sign
Manufacturer: The Great Outdoor Gym Company
Surface Type: Grass
Item Quantity: 1
Equipment Compliance: N/A
Surface Area Compliance: N/A

This item is satisfactory - no work required -

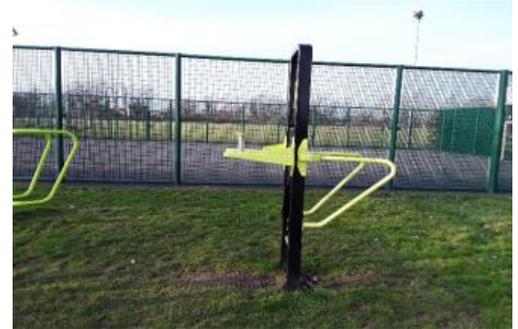
Finding 1

i 4 - Very Low Risk

Item: Leg Raise
Manufacturer: The Great Outdoor Gym Company
Surface Type: Grass Matrix Tiles
Item Quantity: 1
Equipment Compliance: Yes
Surface Area Compliance: N/A

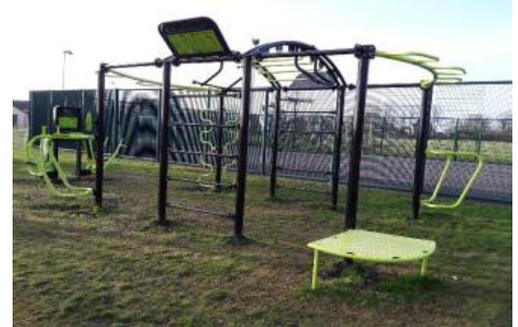
Finding 1

Item: Fit Point
Manufacturer: The Great Outdoor Gym Company
Surface Type: Grass Matrix Tiles
Item Quantity: 1
Equipment Compliance: Yes
Surface Area Compliance: Yes

This item is satisfactory - no work required -
